Troubleshooting the ACR MRI Accreditation Phantom Tests

Troubleshooting the ACR MRI Accreditation Phantom Data

Geoffrey D. Clarke
University of Texas Health Science
Center at San Antonio

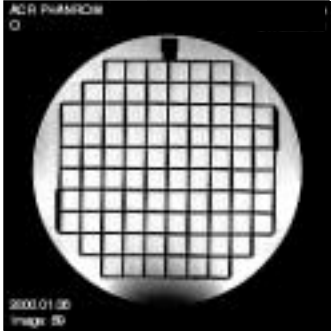
Truncation (Gibbs) Artifact

- Appears as lines of alternating darkness and brightness
- Occurs in both read-out and phase-encoding directions

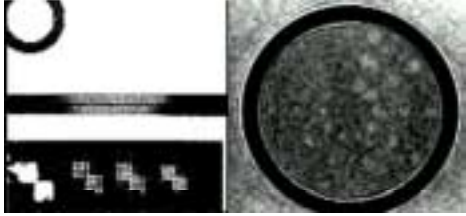
Gibbs Artifacts

- Most problematic in slice select and low contrast detectability inserts

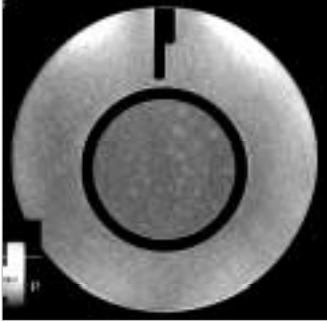
Excessive Truncation Artifacts

If receiver bandwidth is set too low, images become susceptible to major truncation artifacts.

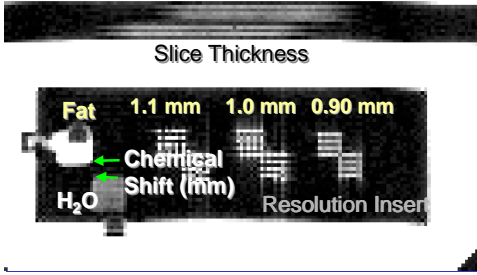
ACR MRI Phantom Chemical Shift Insert

Slice Thickness

Fat 1.1 mm 1.0 mm 0.90 mm

Chemical Shift (mm)

H₂O Resolution Insert

Distance between Fat & Water represents the amount of the field of view which spans 3.5 ppm of the resonant frequency.

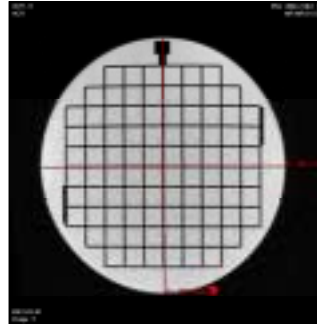
Geometric Accuracy

- Measure distance along main axes of phantom
- Compare with known values

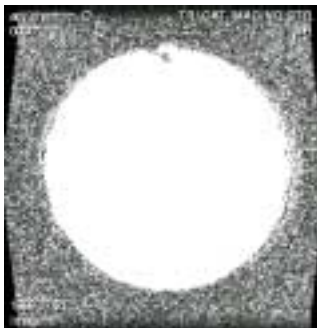
Gradient Correction

- If gradients are inherently non-linear gradient correction may be applied

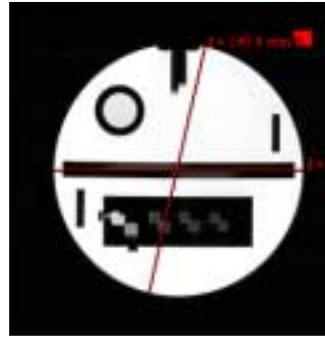
Air Bubble

- When air bubble is in phantom, geometric distortion measurement may have to be taken along diagonal

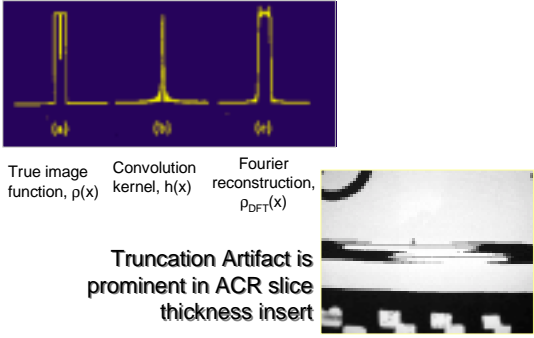
Truncation Errors (Gibbs Artifact)

True image function, $p(x)$ Convolution kernel, $h(x)$ Fourier reconstruction, $p_{DFT}(x)$

Truncation Artifact is prominent in ACR slice thickness insert

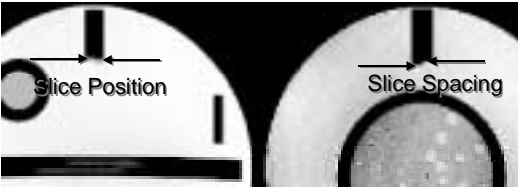
SLICE #1 SLICE #11

Slice Position Accuracy

Crossed wedges should be of equal length if position and spacing are accurate

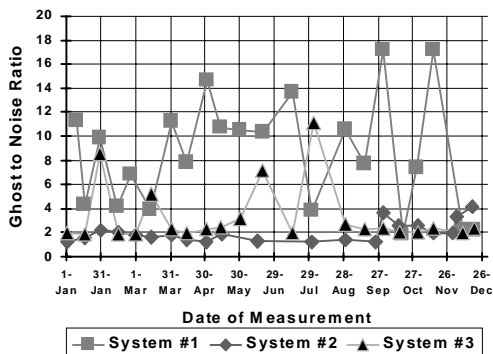
Ghosting - T2-Weighted, Center Slice

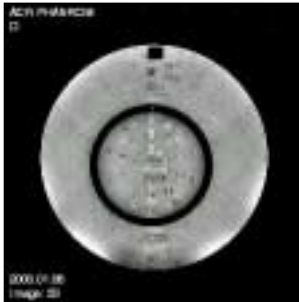
Ghosting Artifact

- Ghosting may obscure otherwise visible LCD spokes

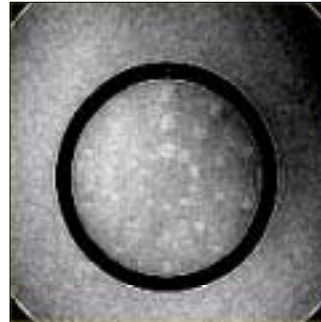
Excessive Edge Filter

- Edge filter increases truncation artifact, obscures outer holes of LCD spokes
